**STATE CAPITOL REHABILITATION AND
RENOVATION / CAPITOL SQUARE PROJECT**

**SERIES 2 - WYOMING STATE CAPITOL
SD OWNER REVIEW**

LEVEL III SCHEMATIC DESIGN REPORT
VOLUME I OF III

ASSESSMENT AND RECOMMENDATIONS

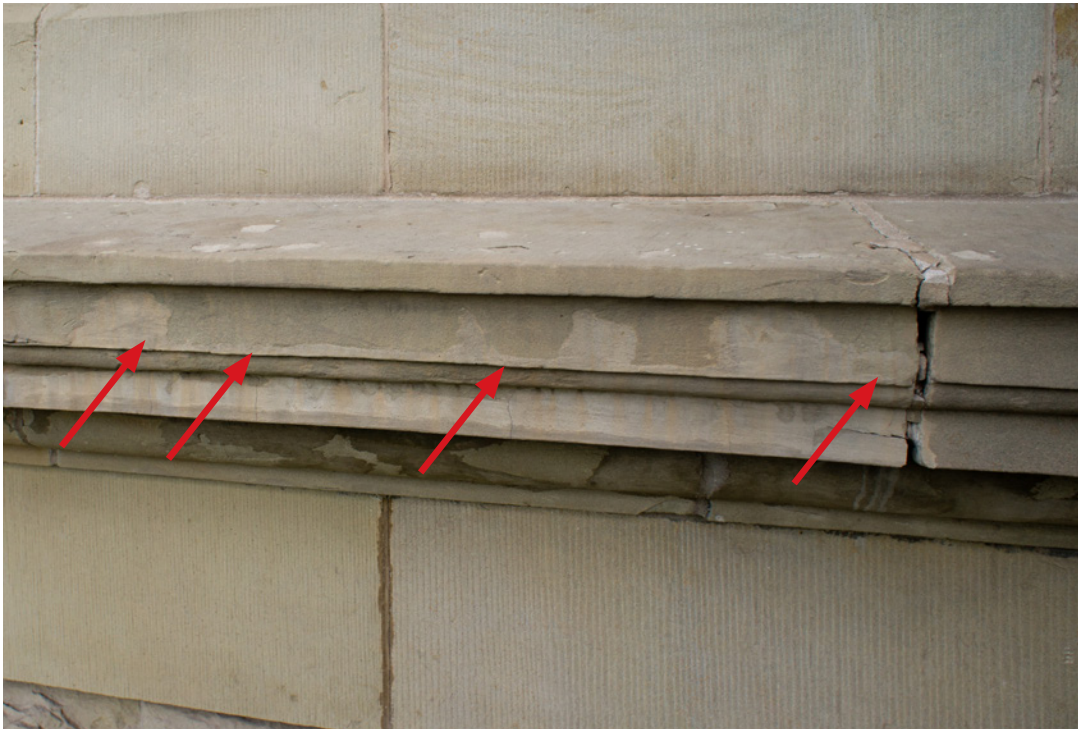
Figure 6.4.3.24: Cracked and Failed Patch Repair at the Cornice at the South Entrance. Some of the patches are in danger of breaking off and falling.

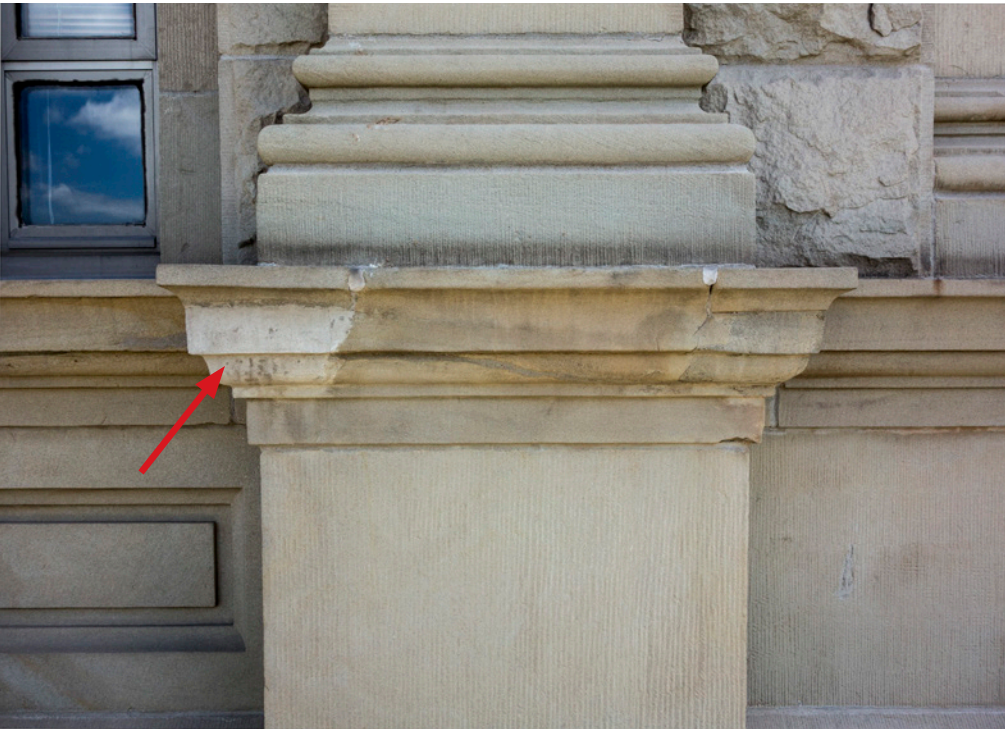
Figure 6.4.3.25: Poor Patch Repair at West Elevation.

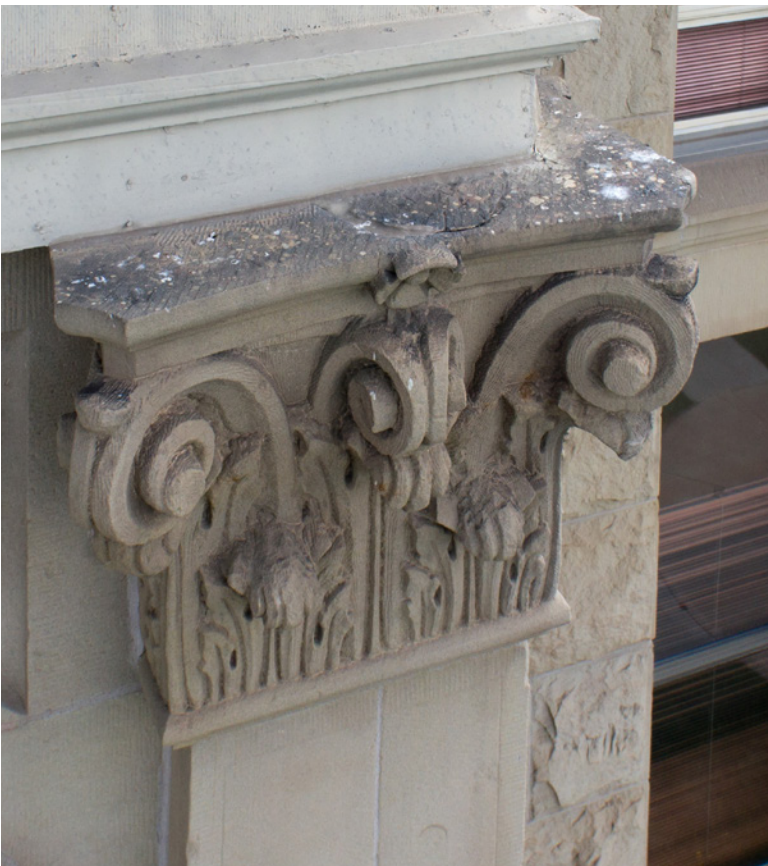
Figure 6.4.3.27: Typical Accumulations of Guano at the Top of the Pilaster Capitals.

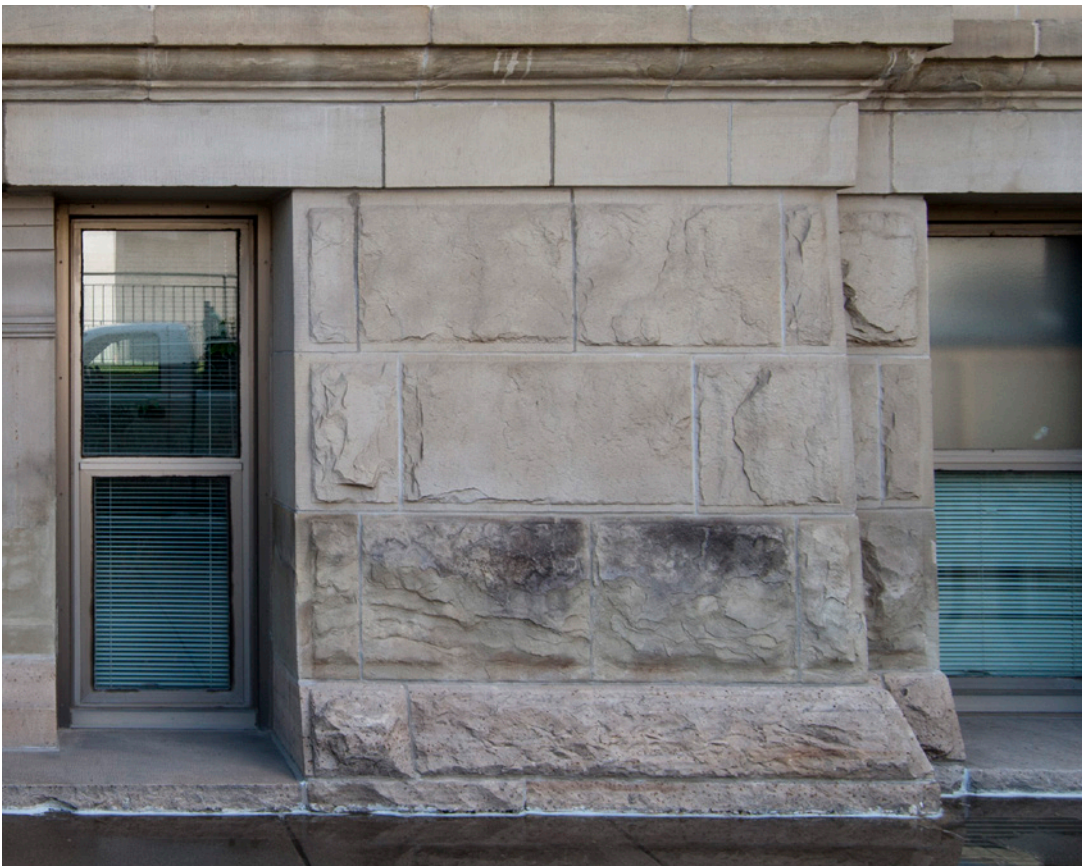
Figure 6.4.3.28: Biological Staining at Base of Building.

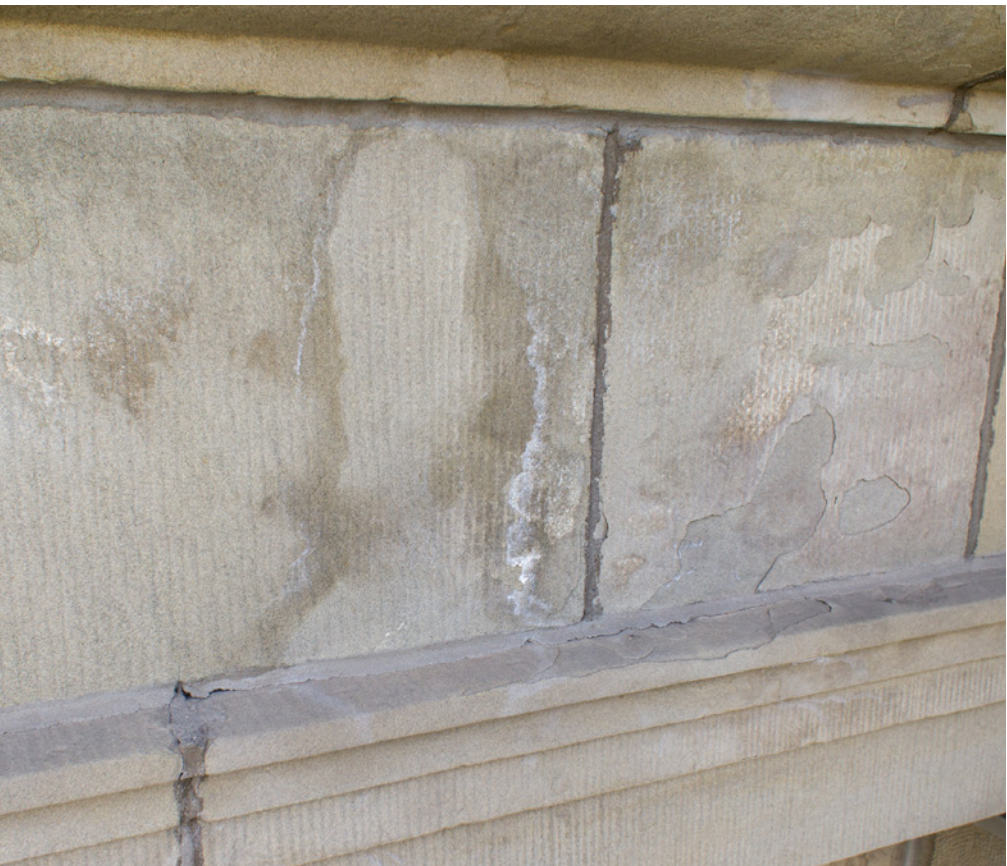
Figure 6.4.3.29: Efflorescence and Delamination at Some Locations in the Entablature Below the Cornice.

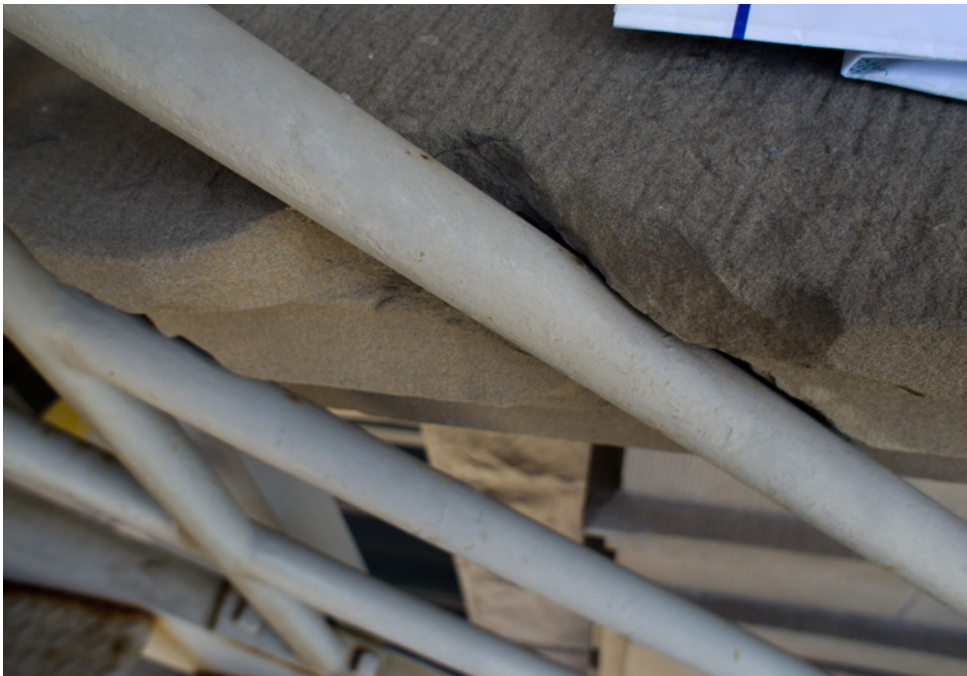
Figure 6.4.3.31: Masonry Cut and Damaged to Accommodate the Fire Stair Handrails at the North Elevation.

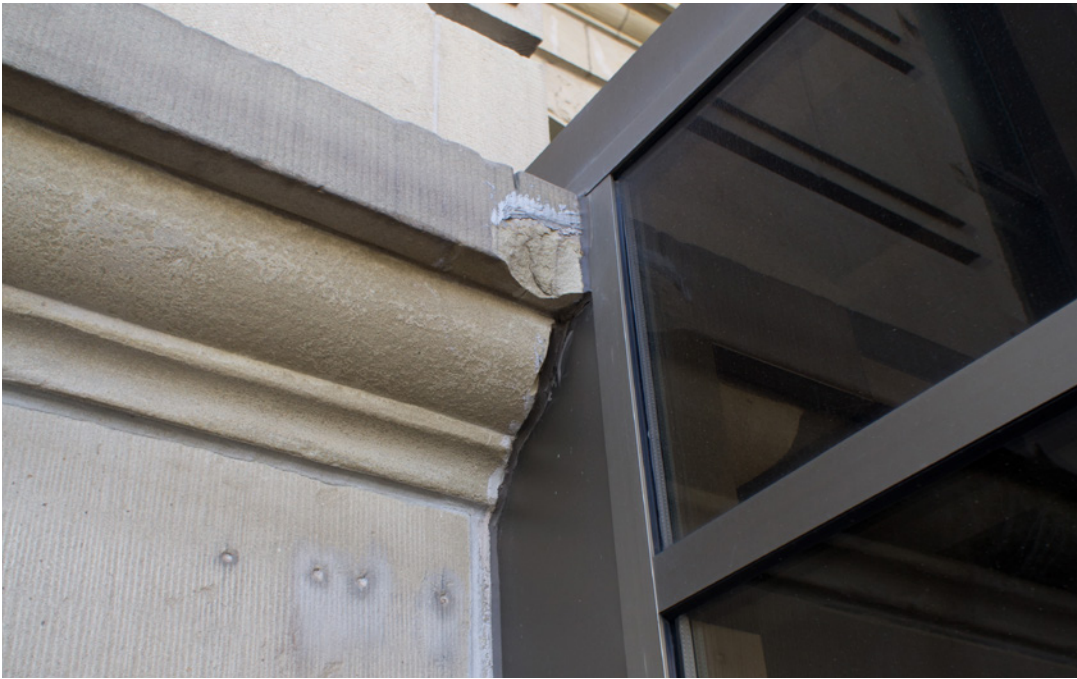
Figure 6.4.3.34: Spalled Stone Adjacent to Glass Enclosure at the North Elevation.

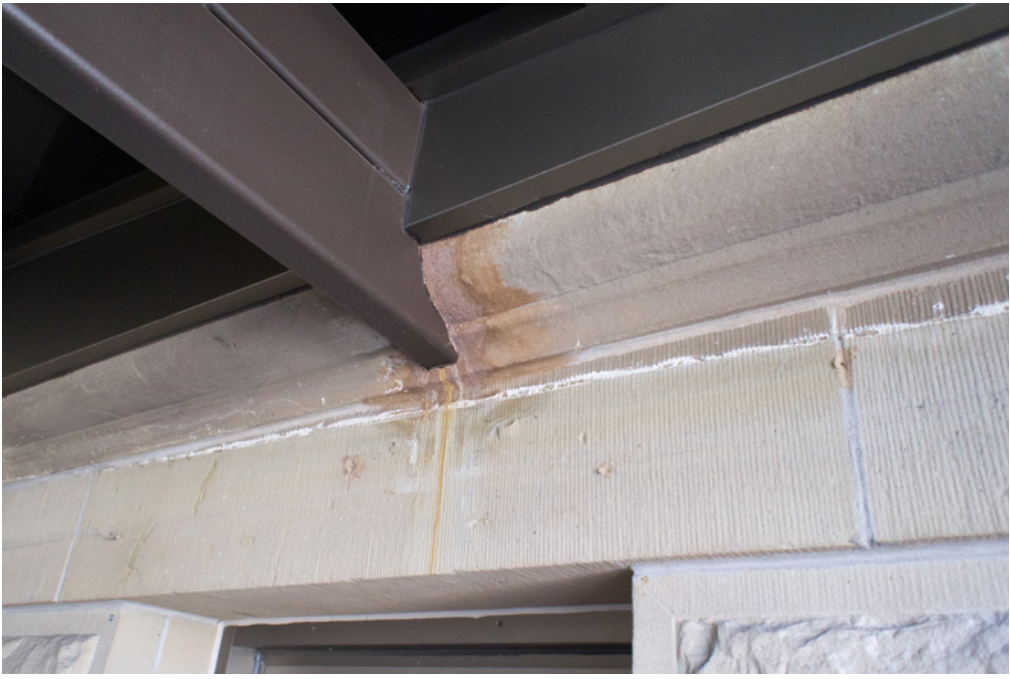
Figure 6.4.3.35: Damage and Staining to Stone Caused by Installation of Steel Structure at Glass Enclosures at the North Elevation.

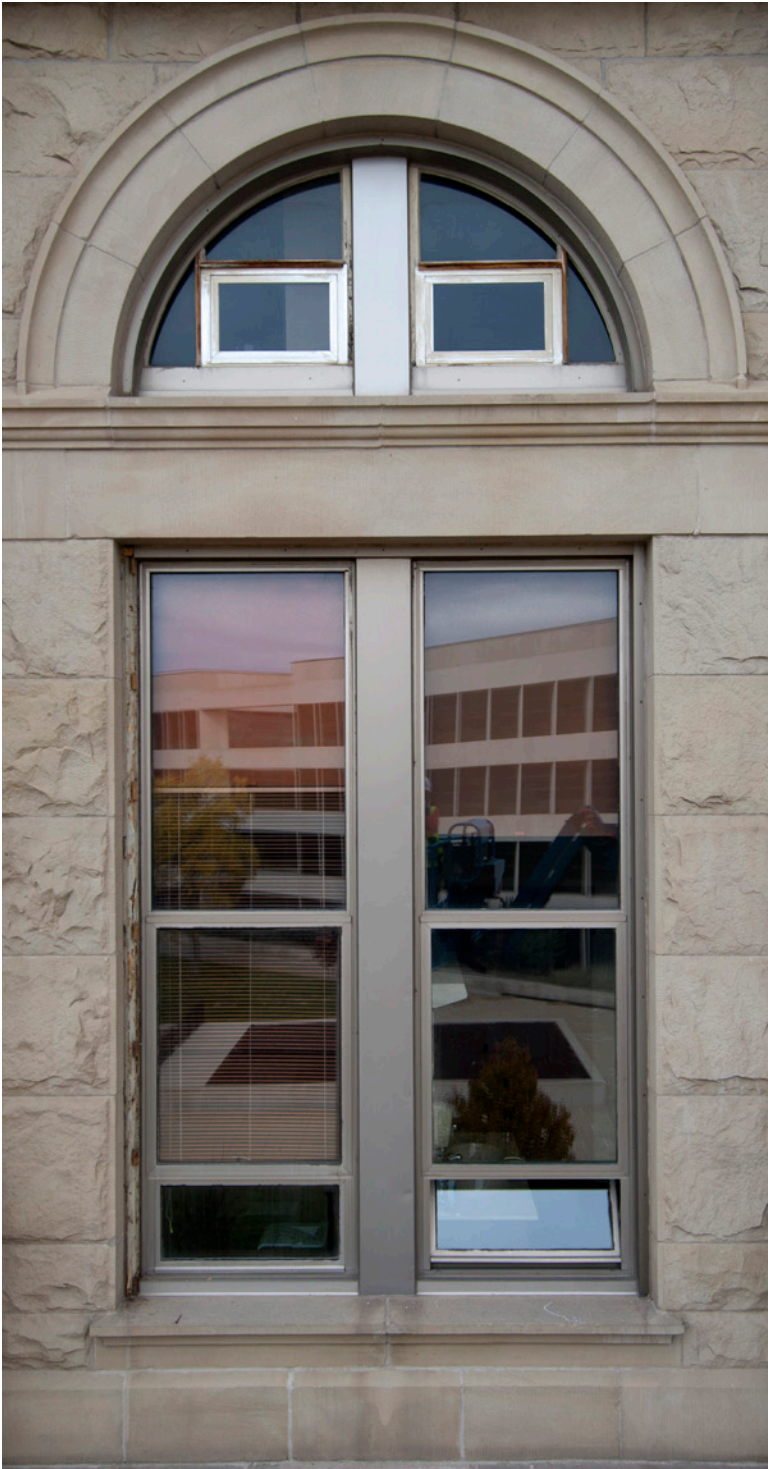
Figure 6.4.3.39: Windows N240A/B, and N340A/B with Applied Aluminum Cladding at Arched Wood Sash and Replacement Aluminum Sash at Rectangular Windows. Aluminum Cladding Conceals the Original Wood Frame, Revealed at Left Jamb.
